# Manhole Inspection Summary

Manhole # S31E\_\_016MH

Insp Date: **8/8/08 11:05 AM**

**Location** Address: **110 n eutaw st**

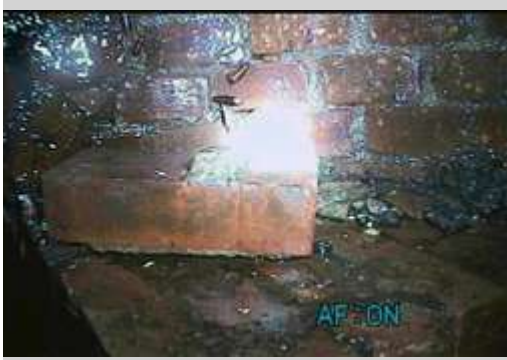
Misc

bench debris

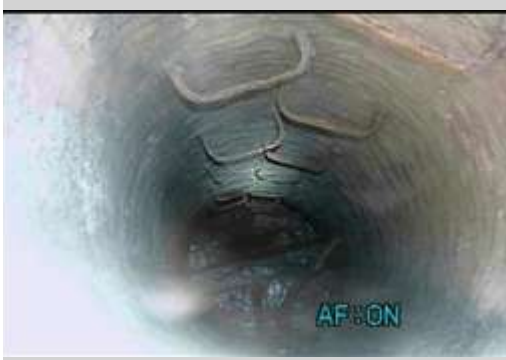
Defect 2

Count: **12** Missing: **1** ☒ Corroded

steps

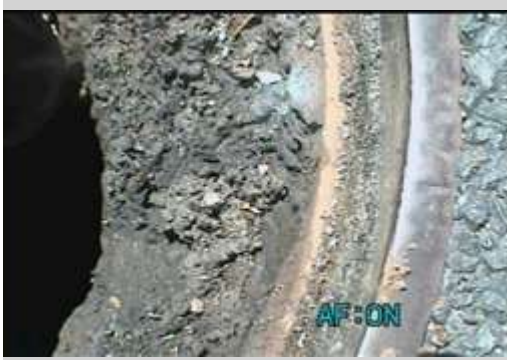
Defect 1

Offset: **6** (in.)

offset

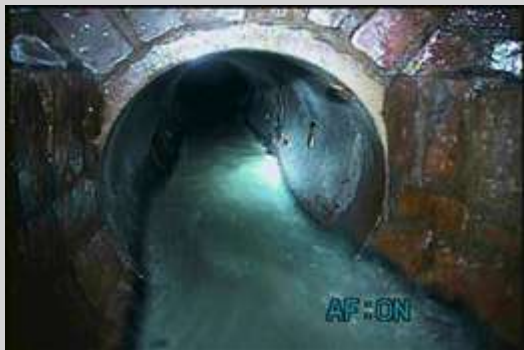
12 O'Clock Outflow

10 in. Circular Gravity Sewer  
Pipe Out @ 12 OClock

Invert Depth: 18.25 (ft.) Flow Characteristics: Fast

Infiltration: None Pipe Seal Cond: Unknown

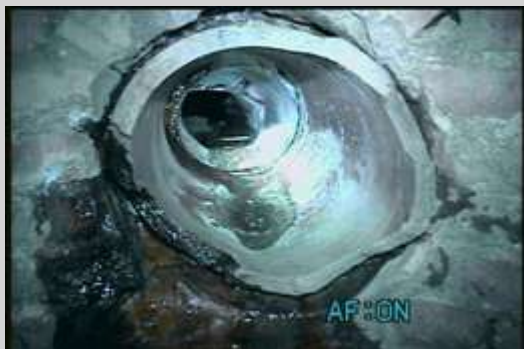
3 O'Clock Inflow

10 in. Circular Gravity Sewer  
Pipe In @ 3 OClock

Drop In @ 3 OClock

Drop: Outside Direct

Drop Condition: Open

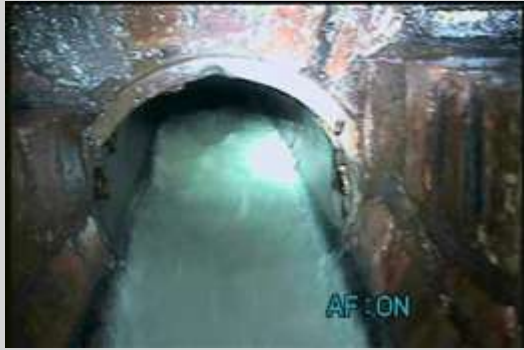
6 O'Clock Inflow

10 in. Circular Gravity Sewer  
Pipe In @ 6 O'Clock

Invert Depth: **18.20** (ft.) Flow Characteristics: **Fast**

Infiltration: **None** Pipe Seal Cond: **Unknown**
